Evaluation of Historic Buildings Reparation in Tripoli, Libya

Abstract: Historic buildings are regarded as a national heritage for their countries and therefore worthy of conservation. In an attempt to conserve them, various forms of intervention have been made over time. These interventions often lead to a problem when performed without adherence to architectural conservation principles. This paper aims to examine the compliance of reparations of historic buildings in Tripoli, Libya to architectural conservation principles and to discuss the main reasons that led to contradictions to these principles. The research demonstrated that about 40% of the observed works comply with architectural conservation principles. The main reasons that led to the contradictions are lack of knowledge and lack of proper repair materials in the local market in addition to security and safety. The findings have practical significance and provide lessons learned from successful and unsuccessful experiences that should be passed into future repair works to avoid a repetition of mistakes. **DOI:** 10.1061/(ASCE)AE.1943-5568.0000427. © 2020 American Society of Civil Engineers.

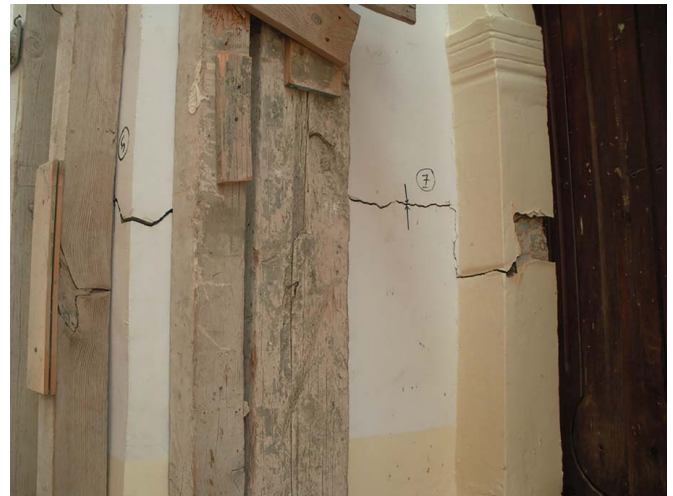
Fig. 2. Al-Mushat mosque, monitoring cracks on a wall.

Furthermore, for diagnosing the situation of cracks in the walls of al-Mushat mosque and Islamic museum, a process of checking the expansion of cracks (Figs. 2 and 3) is used. Expansion of a crack indicates that there is a foundation or a wall problem, whereas

the stability of the crack indicates that the situation is unharmed. Diagnosing HBs’ condition is an essential work for conserving them, as Brereton (1991, p. 7) stated: “It is essential to identify causes before specifying remedies and in pursuit of this there is a need for a careful and accurate diagnosis including, where appropriate, monitoring of the structure.” This complies with the “repairing should be sensitive” principle.

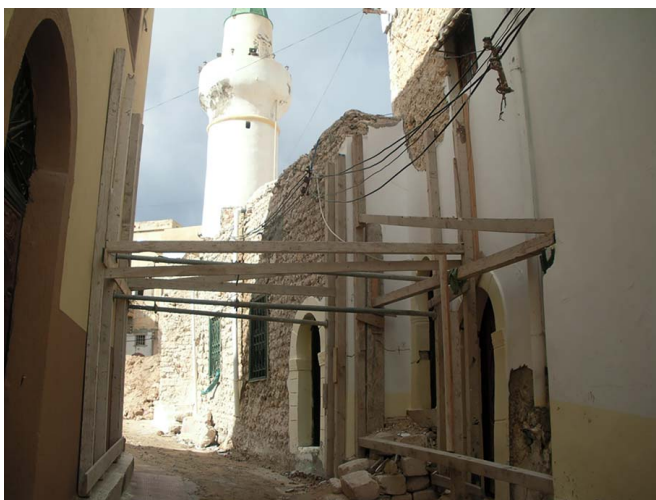
Fig. 1. Al-Mushat mosque, consolidation of cracked walls during refurbishment work.

In al-Mushat mosque, the cracked walls were supported during the repair work (Fig. 1), this process is essential to avoid more damage or risk of failure. According to British standard BS7913 (BSI 1998), the priority should be given to the “work which should be put in hand without delay for health and safety reasons, to prevent imminent damage or to arrest rapid deterioration.” Supporting the cracked walls is at the top rank of the priority of work in HBs and complies with the “Repairs should be sensitive” principle.

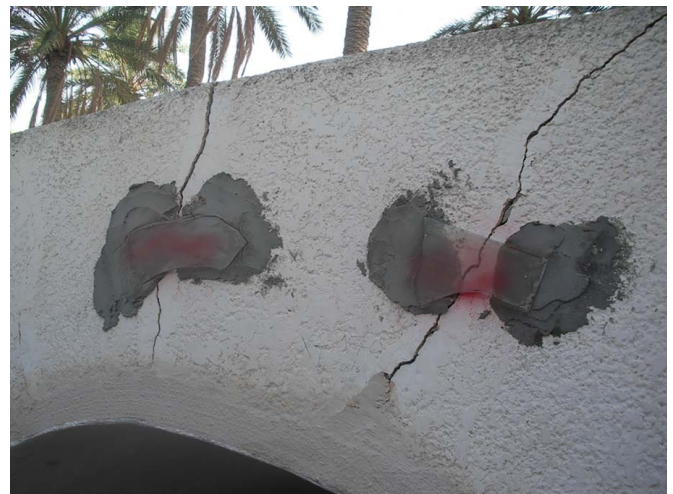
Fig. 3. The Islamic museum, checking the expansion of cracks.

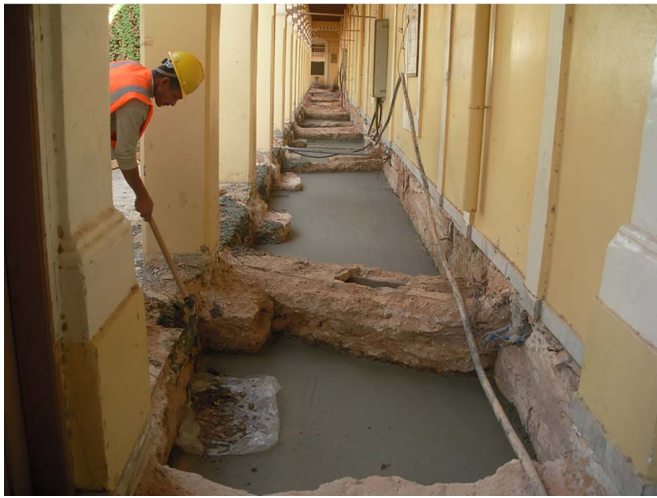
Moreover, for supporting the foundations of the arts and crafts school there is exaggerated use of reinforced concrete (Fig. 4). This practice contradicts conservation principles in terms of “minimal intervention,” although reinforced concrete is a suitable material for supporting foundations due to its strength and flexibility. There is a level of uncertainty about the amount of reinforced concrete required to support foundations to keep the building safe. Furthermore, there is harmful use of reinforced concrete for treating cracks in the former British consulate (Fig. 5). Instead of grouting the cracks with a proper material such as lime pozzolan mortar (Torgal et al. 2012), some stones were removed and replaced by reinforced concrete. This contradicts conservation principles in terms of “minimal intervention” and “repairs should be sensitive” and “repairs should be reversible.” In such a case, the

Fig. 4. The arts and crafts school, exaggerated use of concrete.

main reason that led to contradiction to conservation principles is lack of knowledge regarding treating cracks.

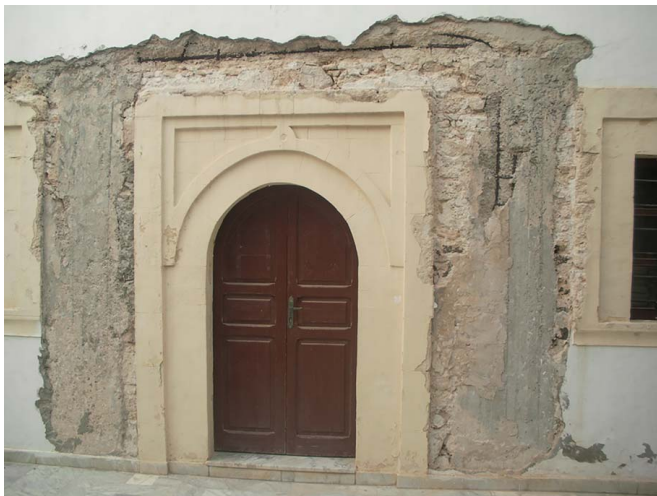
Fig. 5. The former British consulate, exaggerated and inappropriate use of reinforced concrete.

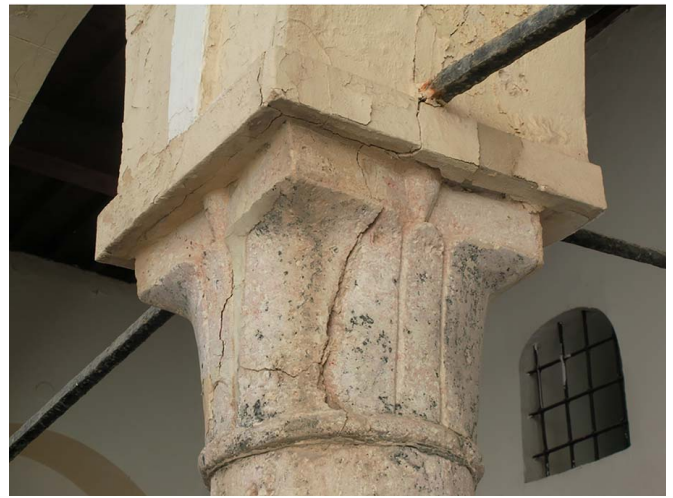
In the former British consulate, in an attempt to consolidate arches, wrong metallic ties were used to support the arches horizontally. This caused cracks in the capitals of columns (Fig. 6). This contradicts the “repair should be sensitive” principle. The main reason that led to the contradiction in this case is a lack of knowledge regarding proper metallic ties for supporting arches. However, in the Islamic museum, prestressed metallic ties were used to prevent horizontal forces in arches (Fig. 7). This process complies with the “repair should be sensitive” principle.

Fig. 6. The former British consulate, inappropriate metallic ties were used to support arches.

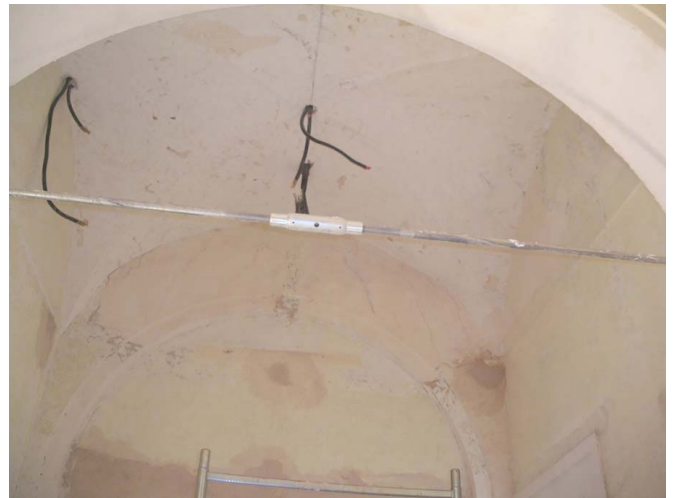
Fig. 7. The Islamic museum, prestressed metallic ties were used to support arches.

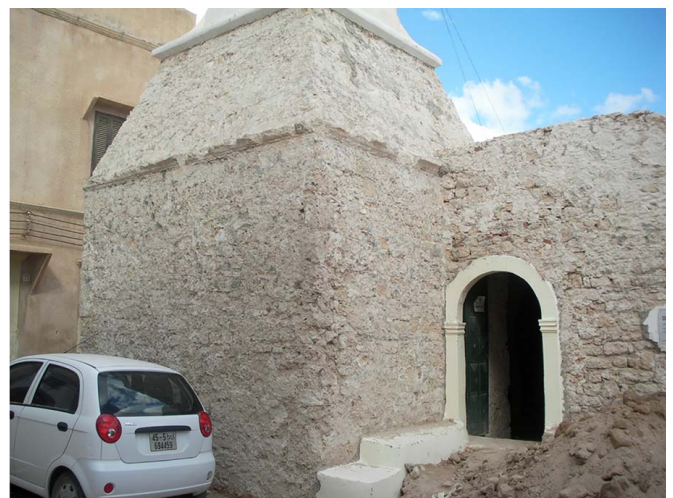
In al-Mushat mosque, for treating dampness in walls and ceilings, the reparation depended on removing all internal and external plaster layers (Fig. 8). This is also what occurred in the previous refurbishment works in the former British consulate and the former bank of Rome. In addition to harming and reducing the value of HBs’ fabric, it caused an increase in the cost of repairing work. More harm might be incurred because of uncovered external walls and domes during the rainy season (before replastering).

Fig. 8. Al-Mushat mosque, repair work depended on removing all plastering layers.

This contradicts conservation principles in terms of “minimal intervention” and “repairs should be sensitive.” Repetition of the same mistake in different sites indicates that there is a lack of knowledge. However, identifying and repairing the specific affected areas in the former French consulate (Fig. 9) are economic, easily measured, and comply with “minimal intervention,” “repairs should be sensitive,” and “truth to materials” principles.

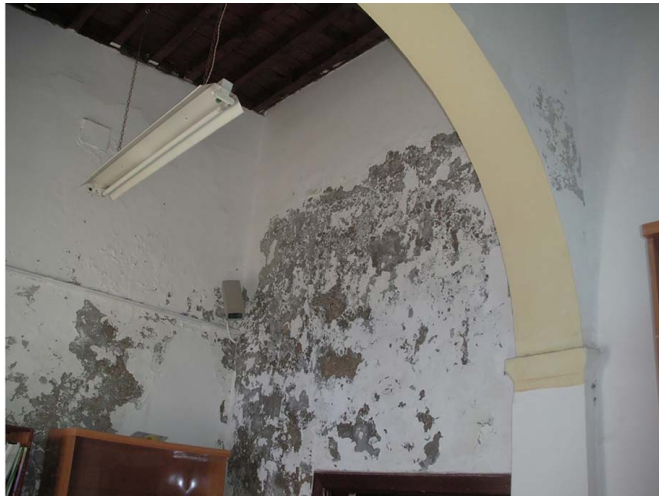
Fig. 10. The former British consulate, dampness in walls.

Furthermore, for treating dampness in the former British consulate (Fig. 10), and the former bank of Rome in Tripoli (Fig. 11),

ordinary cement mortar was used for replastering the walls and ceilings. This caused continuity of the same problem of dampness and serious damage to the HBs' fabric because condensation built up within a stone. In historic buildings, the free movement of water vapor through the fabric of a building in both directions is essential (Edinburgh 2016). This can be achieved when porous materials such as lime components are used for plastering. Moreover, plastering the walls with ordinary cement mortar gives a new appearance to historic buildings. In other terms, HBs appear as new buildings. The use of inappropriate materials results in damage to the cultural value of historic buildings (Myers 1984). Owing to the damage and giving a new appearance to historic buildings, using ordinary cement mortar for plastering HBs' walls and ceilings contradicts “minimal intervention,” “like for like repairing,” “repairs should be reversible,” “repair should be sensitive,” and “truth to materials” principles. Unavailability of proper materials in the local market (lime components are not available often in the Libyan local market) and lack of knowledge (repetition of the same mistake in different sites) are the reasons that led to the contradiction of conservation principles. However, in al-Mushat mosque and the Islamic museum, hydro carbonate lime components were imported and used for replastering (Figs. 12–14). This complies with “like for like repair” principle.

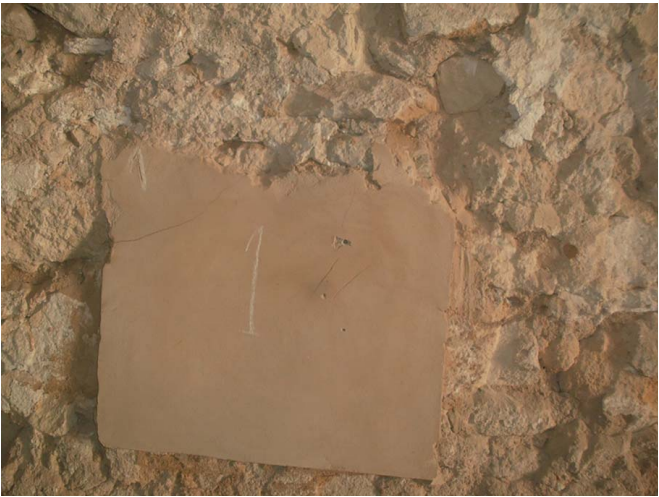
Fig. 13. Al-Mushat mosque, testing hydro carbonate lime mixture.

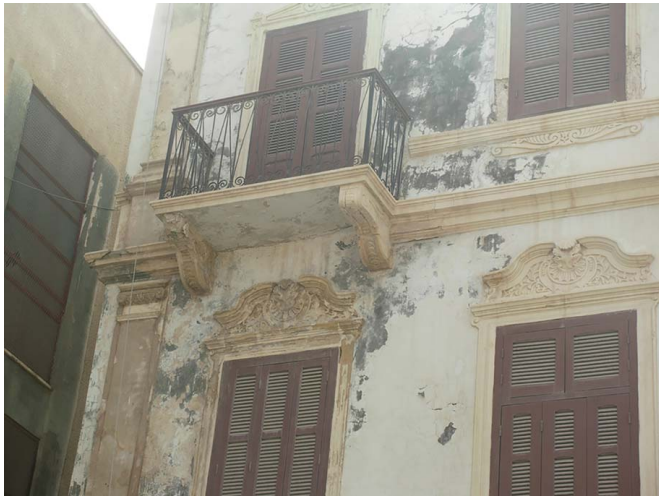
Fig. 11. The former bank of Rome, high dampness in walls.

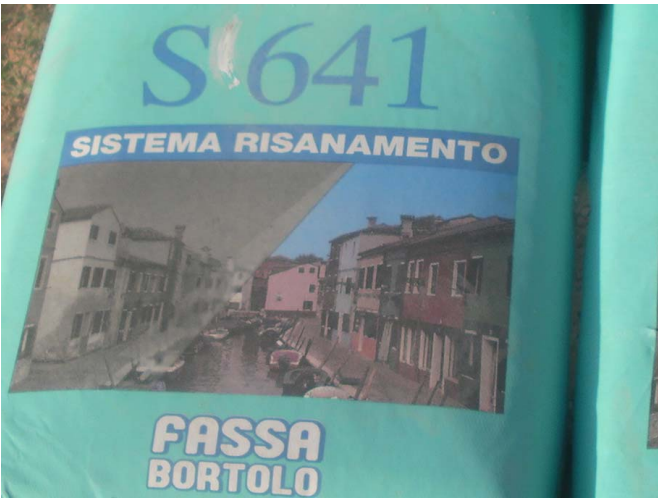
Fig. 14. The Islamic museum, special repair materials were imported for repairing works.

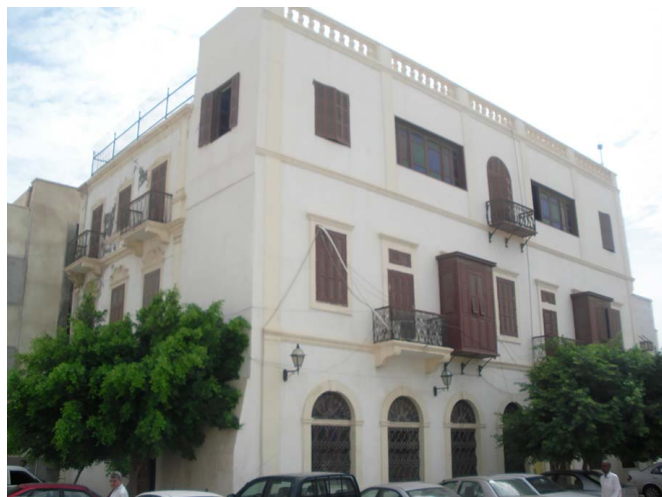
Fig. 15. The former bank of Rome, the main facade was restored according to an old photograph.

The missing cantilevered wooden window in the main facade of the former bank of Rome (Fig. 15) was restored according to the original features that are taken from old photographs. These photos and their dates detail the historic antecedents of the HBs that give insight on the alterations and degradations that occurred in them over time. This helps in conducting

restoration processes correctly and contributes to achieving the “Like-for-like repairs” principle.

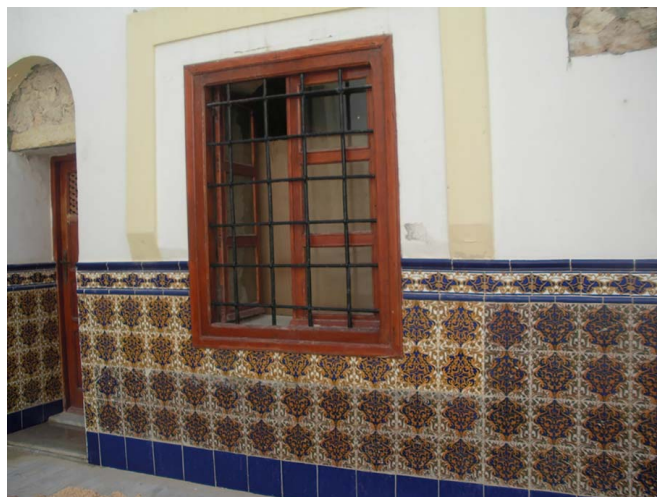
Fig. 18. The former French consulate, distinguishing old and new ceramic tiles.

Furthermore, in the former French consulate, damaged ceramic tiles on the walls of the inner courtyard were replaced with new ones using the same size, materials, texture, and colors. In addition, the old and the new wall ceramic works were distinguished from one another (Fig. 18). This complies with “like-for-like repairs” and “truth to materials” principles.

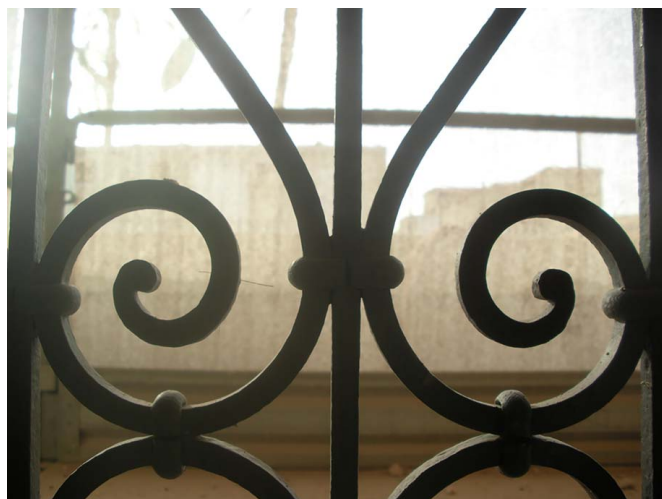
Fig. 16. The Islamic museum, repairing metallic-works.

Furthermore, in the Islamic museum, affected original wooden-works and metallic-works were repaired (Fig. 16). Repairing rather than replacing, contributes to achieving “minimal intervention” and “repair should be sensitive” principles. In the former French consulate, due to uncertainty of the durability of the old wooden windows (a safety reason), the original windows were replaced with new windows (Fig. 17). This contradicts the “minimal intervention” principle. However, the new windows were made of the same materials and methods. This complies with the “Like-for-like repairs” principle.

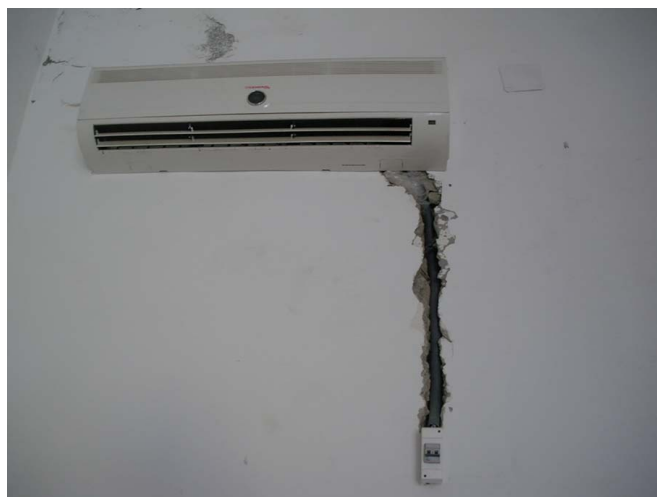
Fig. 19. The former French consulate, electric wires were lined randomly in walls.

In the former French consulate, electric wires were lined randomly in the walls distorting the appearance and negatively impacting the strength of the walls (Fig. 19). This contradicts “minimal intervention” and “repairs should be sensitive” principles. The reason that led to the contradictions might be attributed to a lack of knowledge. However, in the Islamic museum (Fig. 20), underground facilities were established adjacent to the historic building to provide sewage, water, and air-conditioning systems. The concept was to make these services hidden and ensure that they do not have negative impacts on the building in compliance with the “repairs should be sensitive” principle.

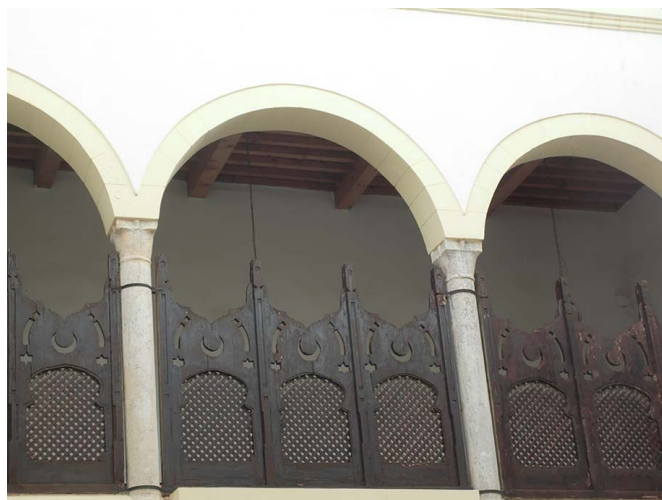
Fig. 17. The former French consulate, using the same materials for restoring the original wooden-works.

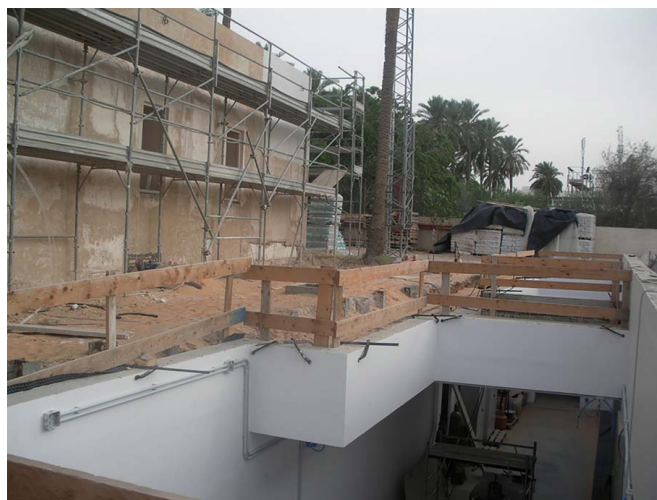
Fig. 20. The Islamic museum, underground water supply, sewage, and air-conditioning systems were established adjacent to the museum.

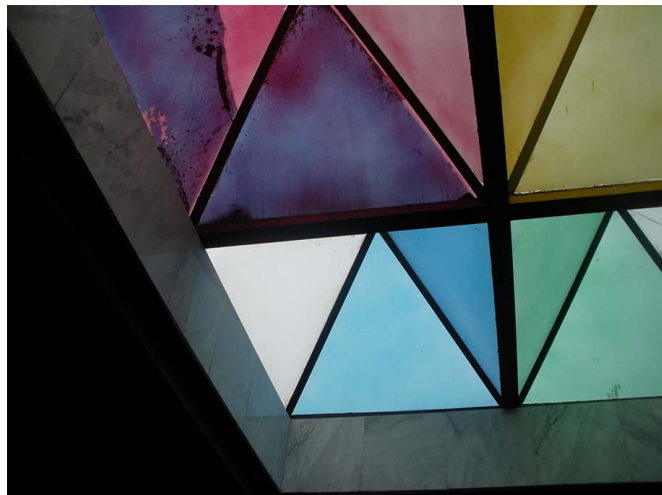
Fig. 21. The former bank of Rome, a modern material was used to cover the internal courtyard.

Furthermore, the internal courtyard of the former bank of Rome (Fig. 21) is covered with modern demountable materials. This attributed to the new function of this building, which is a branch of al-Umma bank (Libyan bank). Although modern materials are inappropriate for HBs, a security reason forced the contradiction to the “like for like repair” principle. However, using materials that can be dismantled and removed from their setting complies with HBs conservation principles in terms of “Repairs should be reversible.”
